DM2000: A Powerful Tool for Asset Management

Hainan Fudao Chemical Industry Co. Ltd. (HFCI) is located in Dong Fang, Hainan province, in the southernmost part of China. Construction began in 1994 and the facility was commissioned in 1996. There are two main divisions: an ammonia plant and the first granular urea plant in China. Production capacity is 1000 MTPD (metric tons per day) of ammonia and 1765 MTPD of granular urea. Both products are used as fertilizer.

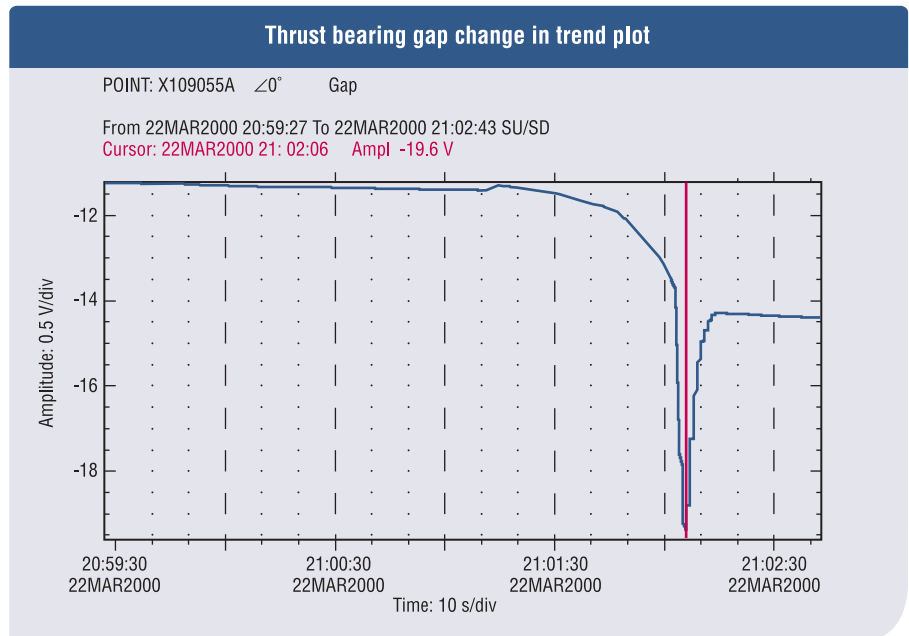
Figure 4.

First, trend data for the steam turbine thrust position was checked. As shown in Figure 4, gap voltage fluctuated from -11.1 Vdc to -19.6 Vdc and came back to -14.4 Vdc within 13 seconds. This was indeed highly irregular and indicative of a problem. Dynamic data from the axial probes was also illuminating, as is shown in the half spectrum cascade plot of Figure 5. This revealed the presence of an unusual subsynchronous component (well below 0.5X), and further

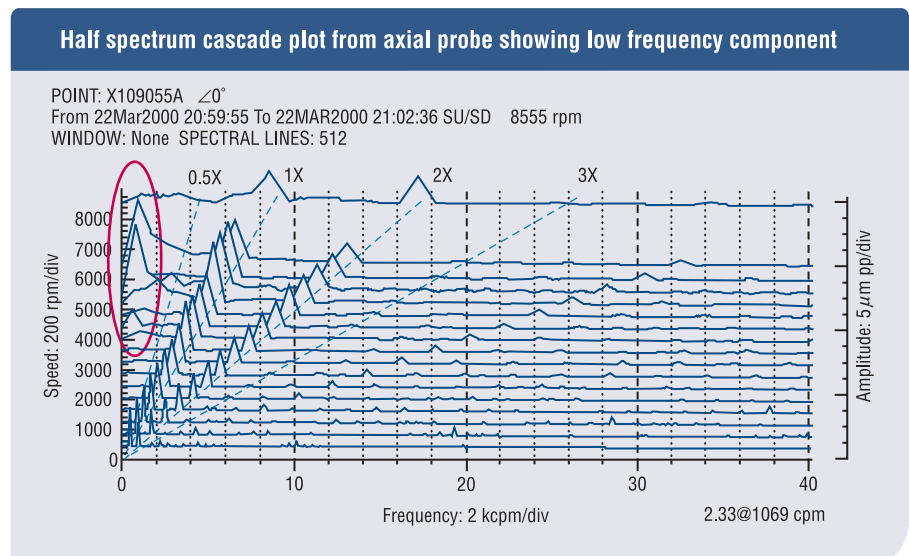
Figure 5.

confirmed that something was wrong in the rotor's axial direction. Other DM2000 data was reviewed as well, but the radial vibration at each bearing did not change much compared to the baseline data. There was no indication, for example, of a radial rub or other anomaly. It was concluded that thrust bearing damage had probably occurred and plans

were made for Maintenance to replace the thrust bearing only. When the bearing was opened up, suspicions were confirmed: the Babbitt metal was severely damaged. After thrust bearing change out, start up was smooth and the machine operated without further problems.

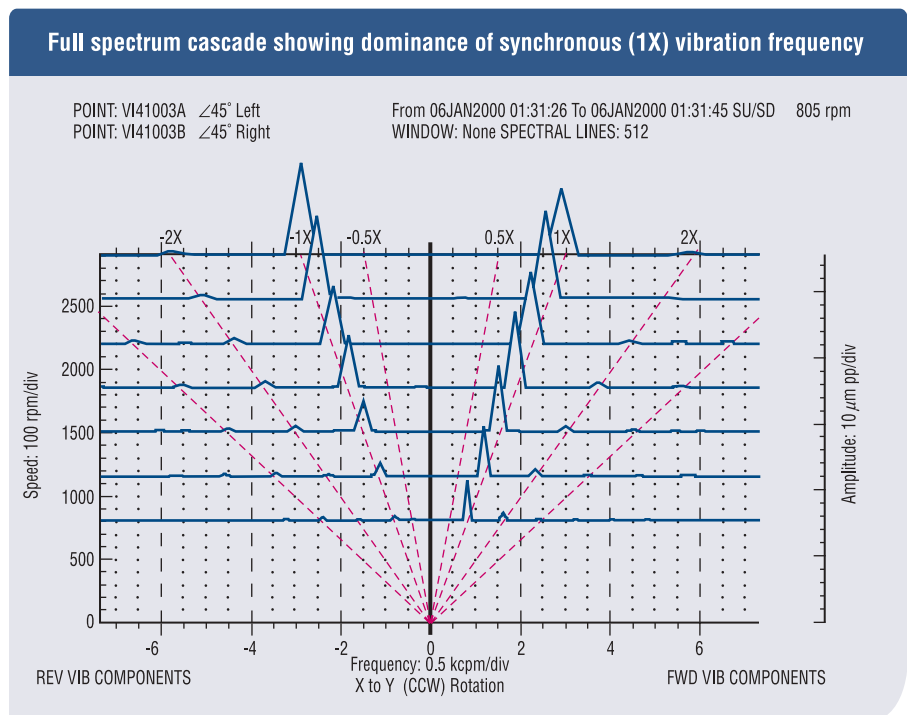
Figure 6.

First, the transient data was reviewed for the steam turbine. Using a full spectrum cascade plot (Figure 6), the major frequency component was synchronous with rotating speed (1X).

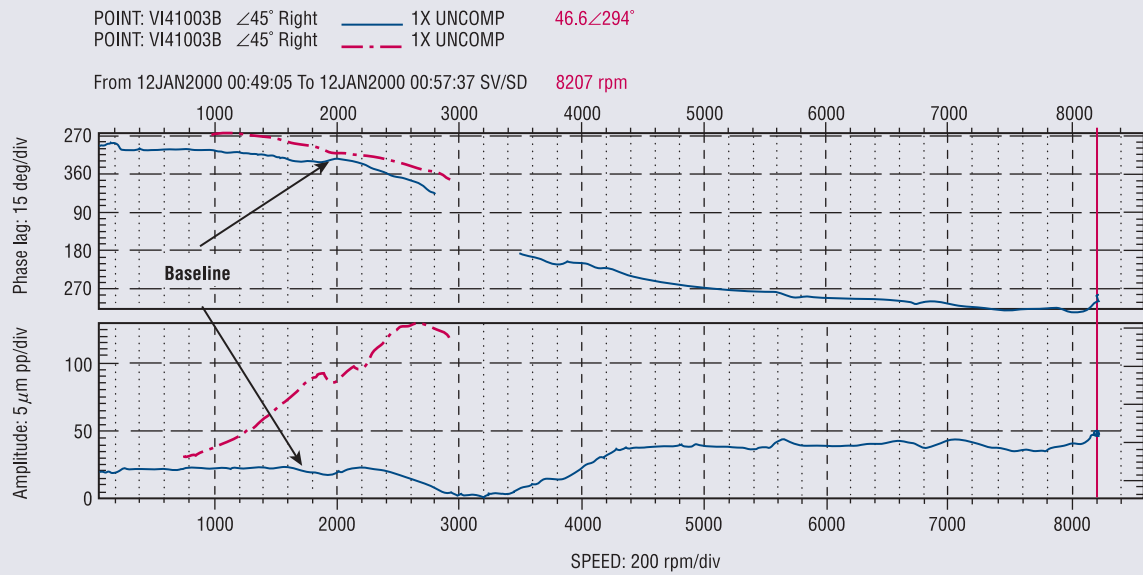
Figure 7.

Bode plots showing aborted startup data compared with baseline data

A Bode plot (Figure 7) was then analyzed. It showed a distinct difference from normal startup behavior, as noted by comparing the baseline data in Figure 7 with the data collected during the aborted startup. A change in balance seemed unlikely, and the immediate suspicion was thermal bow.

It was suspected that the shaft bow resulted from an inadequate startup procedure that did not allow the rotor to warm up and expand properly. A unit restart, using a manually controlled procedure, maintained 1000 rpm for 15 minutes and allowed the rotor to fully warm up and expand. Automated control via the DEH system was resumed and the rotor was ramped up to operating speed. The entire startup was monitored closely, viewing appropriate DM2000 data. Smooth operation was observed throughout and vibration amplitudes were less than 50 μm . This modified startup procedure was determined to be feasible and effective for the CO₂ unit and has been permanently implemented.

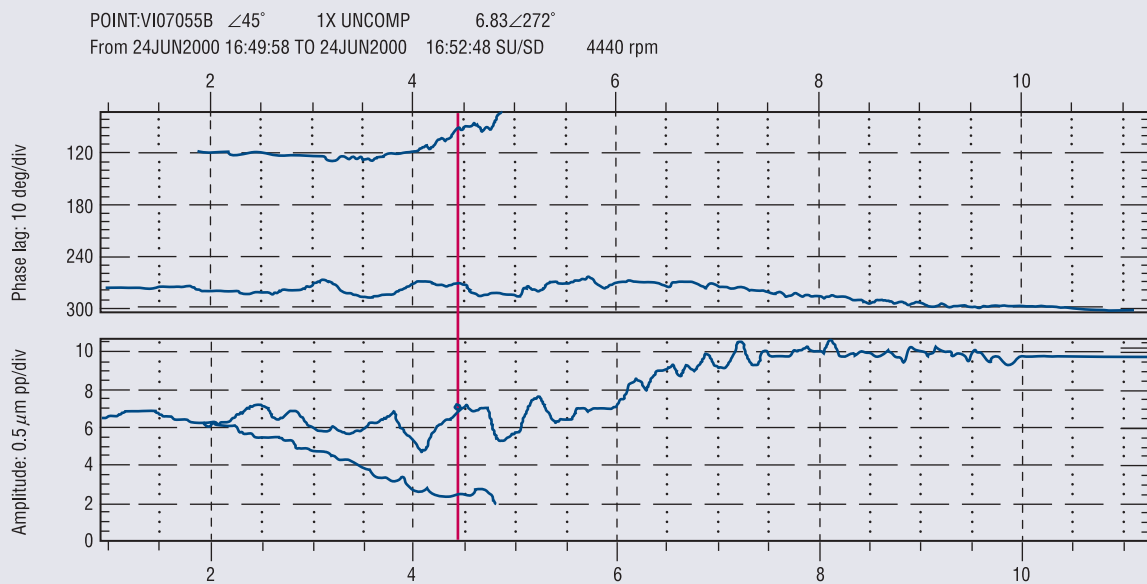
Figure 8.

Bode plots showing data from 920 rpm to 5000 rpm

Because both process and vibration data had been integrated into the DM2000 system, data plots clearly displayed information relating the exhaust valves to the relevant vibration behavior. In Bode plots (Figure 8),

different vibration amplitude and phase was noted from 920 rpm through 4850 rpm than was typical of a startup through the same speed region. A full spectrum waterfall plot (Figure 9) was also examined and revealed a significant reverse precession component, far bigger than the forward component. At this point, it was thought that rubbing may have occurred. However, upon further investigation, the shaft centerline position plot (Figure 10) indicated that reverse rotation rather than reverse vibration had actually occurred. This is illustrated in Figure 11. Please note that the radial bearing used in this machine was a five-shoe, tilting-pad design.

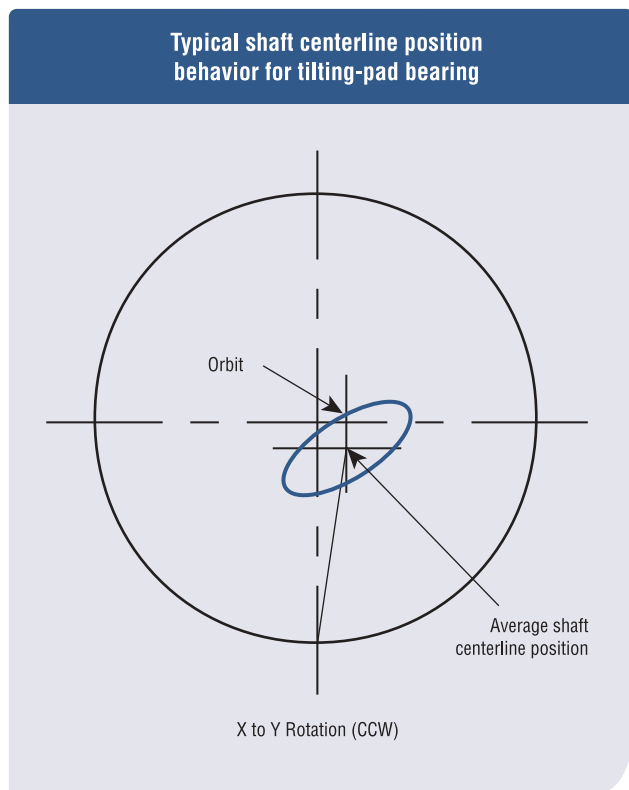
For a Load-on-Pad (LOP) configuration of tilting-pad bearings, the shaft supporting oil wedge is established and position is maintained on the bottom pad. Due to the location of the wedge, the shaft rises essentially straight up into normal running position, although there is a slight offset from the true vertical centerline. Usually, the offset is in the direction of rotation as shown in Figure 11. In general, for a specific bearing, the centerline position will retrace the same pattern each time the machine is started or stopped. Figure 10 shows that as the machine coasted down from 11,269 rpm, the shaft centerline followed a predictable path from slightly right of center toward the bottom of the bearing clearance. This would be predicted from Figure 11. However, when the machine suddenly accelerated from 920 rpm to 4880 rpm it did not retrace the same path of upward and to the right. Instead, it traveled down through the vertical centerline of the bearing clearance and then

upwards and to the *left* – the exact opposite direction one would expect. The combination of reverse precession seen in the full spectrum plot and the data from the shaft

centerline plot strongly suggested a reverse rotation event had occurred.

Reverse rotation generally occurs because either liquid or gas is allowed to flow into the machine in a direction opposite its normal flow. In this case, it was assumed that reverse rotation had resulted due to process gas return into the compressor. Faulty check and cut-off valves were suspected and confirmed and appropriate maintenance on the valves was performed.
